HHSRS Worked Examples from East Midlands  
Standardisation Working Group  
6 March 2008

**Example 18 – Damp and Mould**

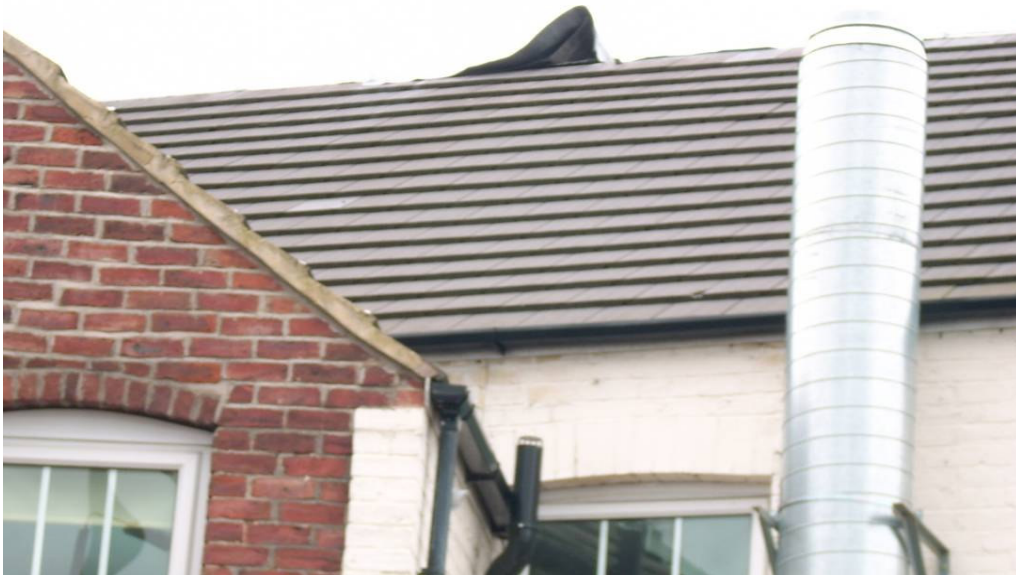
1920's one storey flat with loft space, above a Chinese takeaway shop. It is constructed of solid brick walls, a tiled roof and double glazed uPVC windows. The property contains a living room, kitchen, two bedrooms and a bathroom containing WC, wash hand basin and bath with shower. The property is rented by a single female aged 28. the first picture shows loose lead flashing on the roof.

Justification  
**Damp has already penetrated through the roof and into a bedroom.  
 There is a large amount of damp visible on the bedroom wall**

**Enforcement Action:**  
 The group decided to serve an improvement notice to repair the roof and bedroom wall and to reinstate the loft insulation. The group also discussed using a nuisance notice (s.80 EPA) as the house may be in such a state as to be prejudicial to health.
